Inspection Report

Property Address:
4858 Pleasantview
Kalamazoo, MI 49001

1st Choice Inspection Services

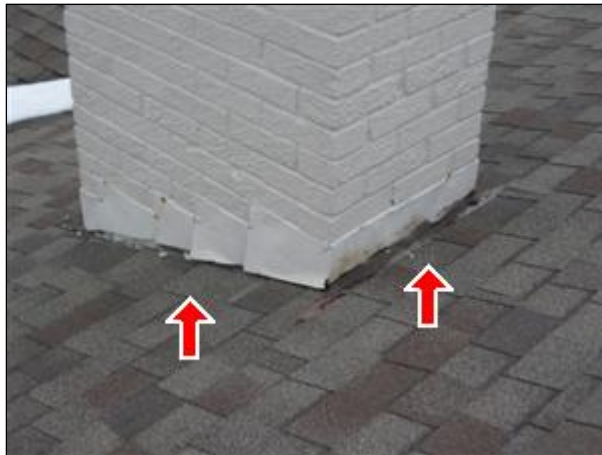
(1) Flashing is rusted and appears to be loose in areas. Recommend that a qualified contractor repair as necessary.

1.1 Picture 1 rusted and loose flashing

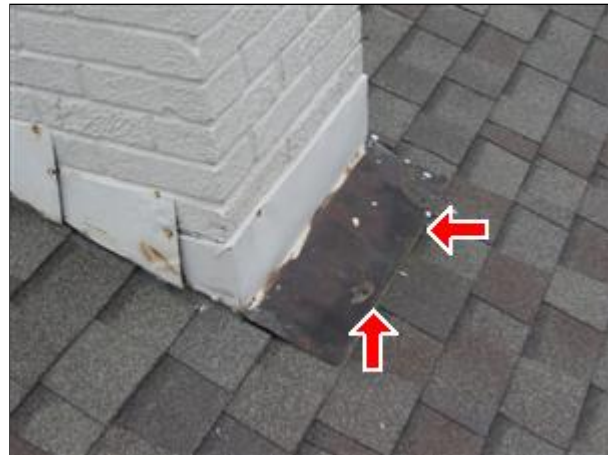
1.1 Picture 2 rusted thru flashin

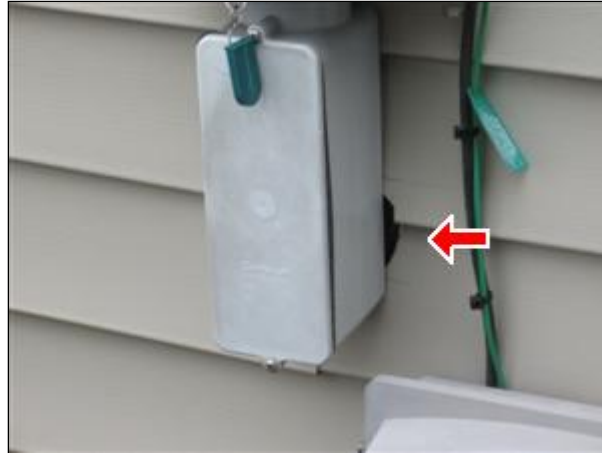
(1) Electrical service entrance has a gap around it. This should be sealed to keep pests and water from damaging the structure.

2.8 Picture 1 electrical service entrance

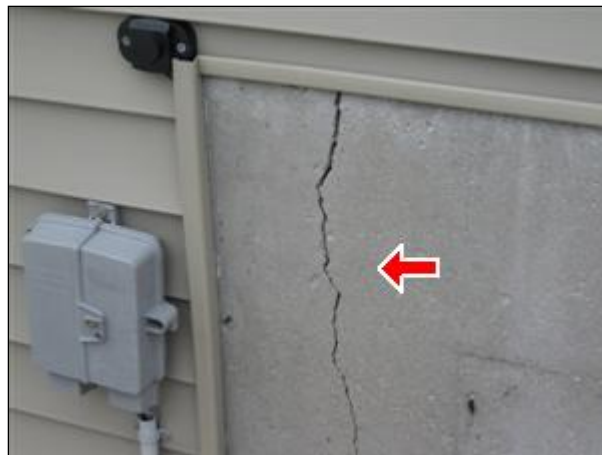
(2) This crack is located on the North side of the garage and should be monitored for further movement.

2.8 Picture 2 crack in foundation on North side of garage

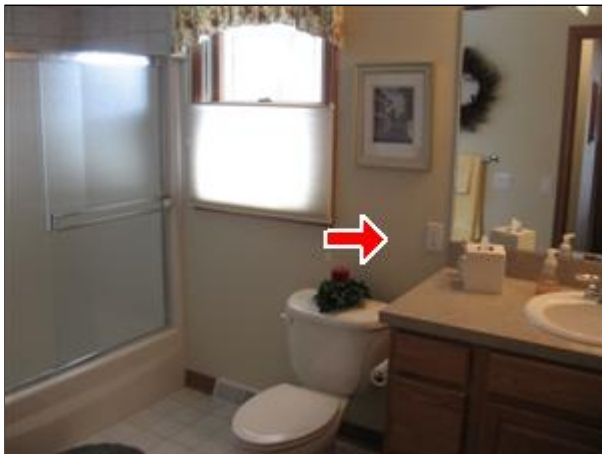
GFCI at sink does not trip. Recommend a qualified contractor repair.

6.5.A Picture 1 GFCI in main floor full bath
